**MUSCATINE CITY COUNCIL  
IN-DEPTH MEETING  
Thursday, April 13, 2023**

Stanley Consultants was selected by a selection committee from three qualified engineering service providers to perform a condition assessment of the Water and Resource Recovery Facility (WRRF), all the City owned lift stations and the gatewells operated along multiple levees in the City. The goal was to establish the general condition of the existing facilities and develop a prioritized capital improvement plan to guide investments in these assets. Each facility was assessed on form, function, redundancy and safety. They were also rated based on consequences of failure. Jay Brady from Stanley Consultants will provide an overview of the Condition Assessment and Capital Improvement Plan Reports including estimated costs associated with the prioritized items and present the working capital improvement plan showing how the City might make investments in these assets over the next 10 years.

**Deliverable:** Capital Improvements Plan  
**Project:** Muscatine WRRF Capital Planning  
**Client:** City of Muscatine  
**Location:** Muscatine, IA

**Deliverable:** Condition Assessment Report  
**Project:** Muscatine WR

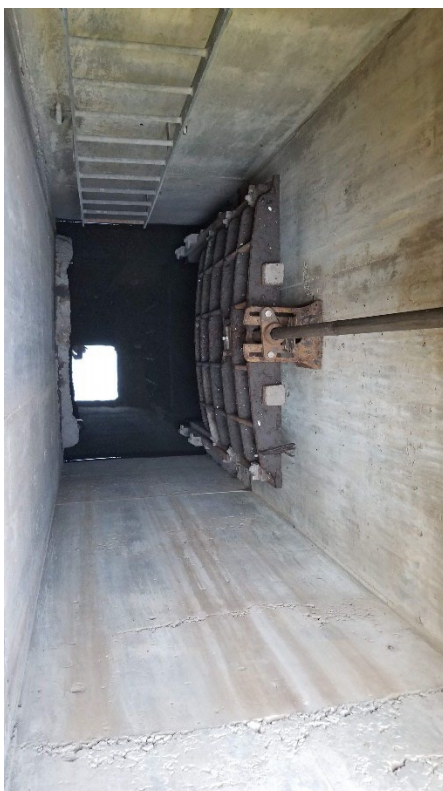
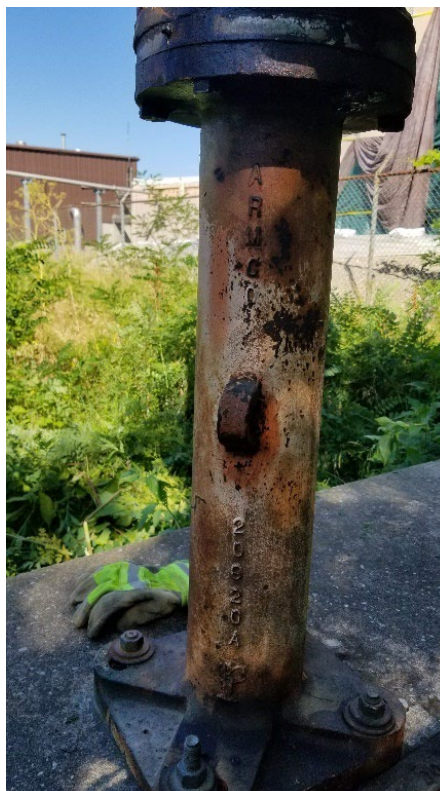
GW5071 is an open storm gatewell that is in good operating condition. It is located on the east side of the Kraft-Heinz Production Facility, facing Mad Creek. The date of the storm sewer installation is not known. The riser stem and actuator show mild to moderate corrosion, but the structure is adequate. It is located in a levee, connected to a gravity-flow storm sewer. The gate is exercised annually.

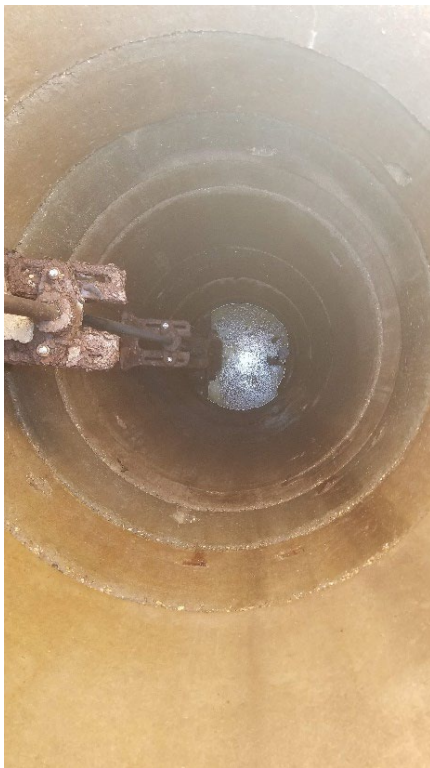
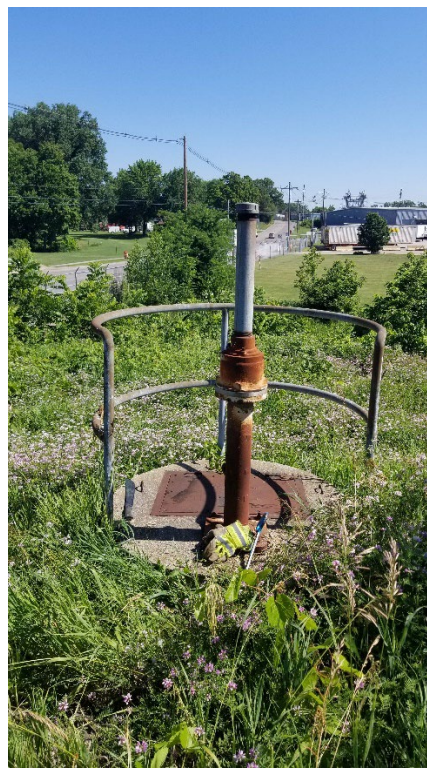
Gatewell 6284 is a sanitary gatewell located alongside Isett Avenue in a nearby levee on the north side of the Kraft-Heinz Production Facility. The gate is operable and is normally in the open position. The riser stem, actuator, and access hatch show mild to moderate corrosion. The gate does not have a good seal, leading to significant leakage when in the closed position. The age of gate is unknown. The pipe upstream and downstream was installed in 1958 and 1980. The gate was originally built by the USACE. If the USACE still requires the gate to be operable then the gate should be replaced.

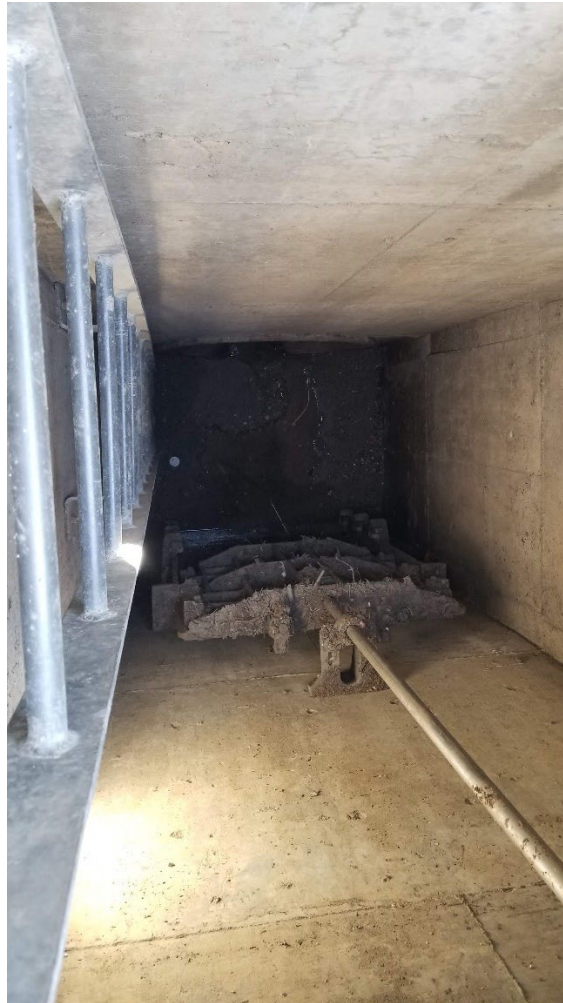
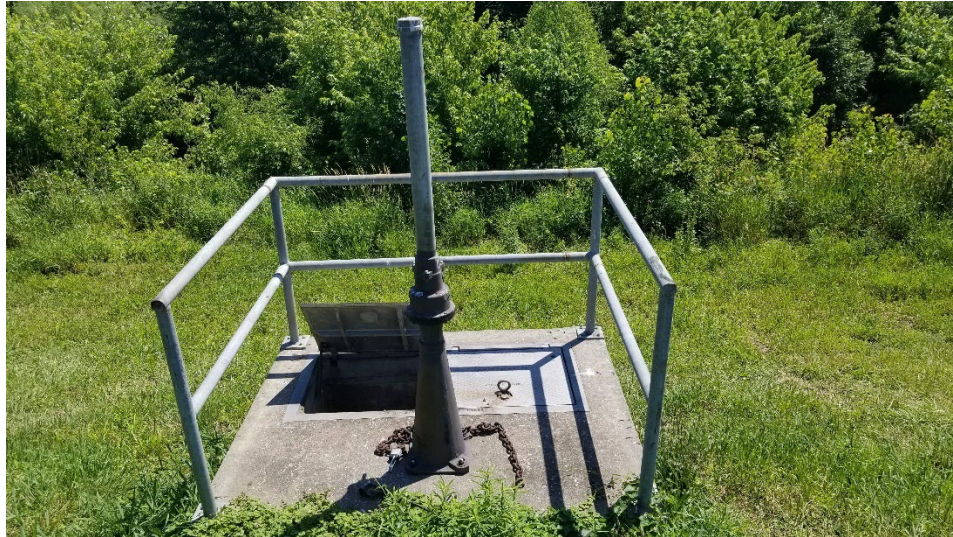
GW3813 is a storm gatewell located along Mad Creek, south of E. 6<sup>th</sup> St. The gate is operable and typically in the open position. Age of gate is unknown. The piping upstream and downstream was installed in 1984. It is exercised annually and is in good working condition.

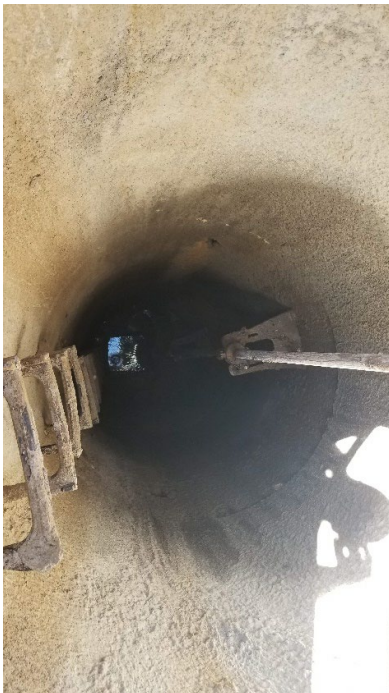
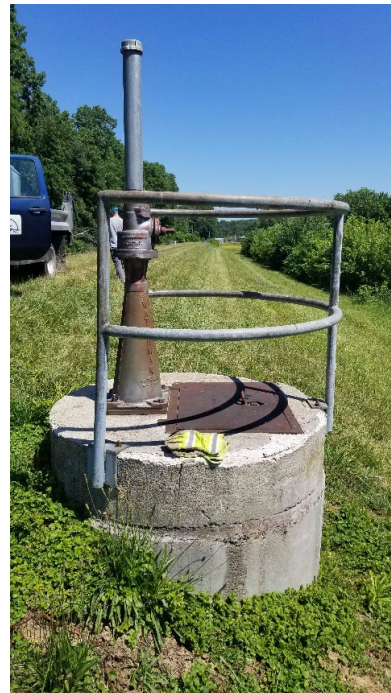
GW3811 is a sanitary gatewell located along Mad Creek, south of E. 6<sup>th</sup> Street. The actuator and access hatch show moderate corrosion. The concrete top has some corrosion and the inside concrete walls show spalling. Age of gate is unknown. The piping upstream and downstream were installed in 1983. The gatewell is exercised annually and is in operable condition based on City staff comments.

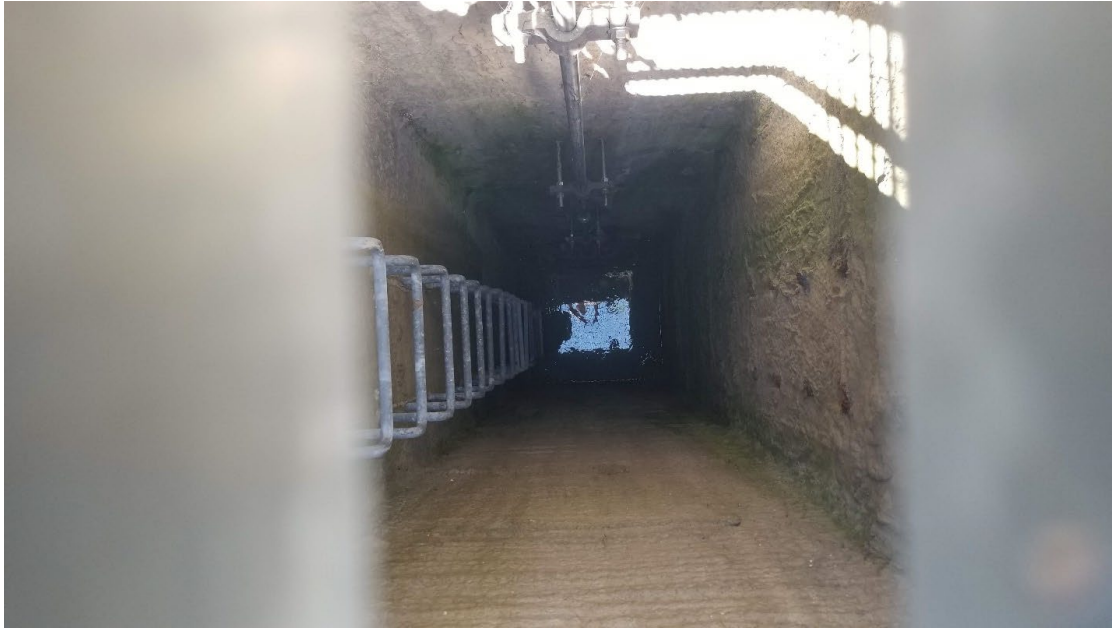
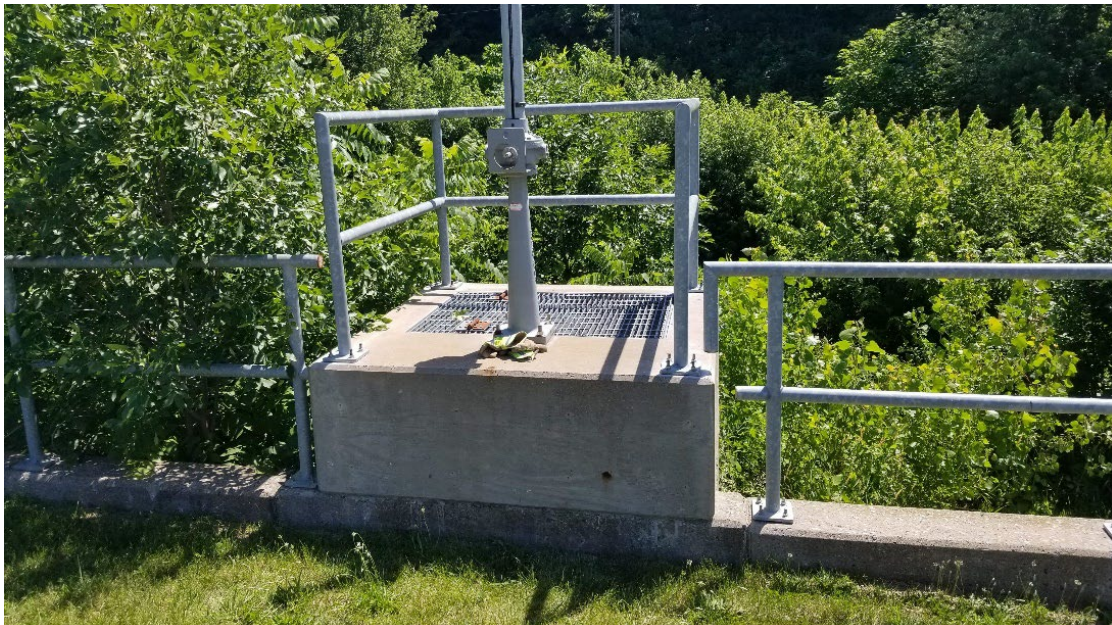
GW3804 is a sanitary gatewell located south of E. 5<sup>th</sup> St. along Mad Creek. The sewer line crosses Mad Creek downstream of the gatewell and the gate would close if there was a break in the sanitary line causing wastewater flows to enter into the creek. A new sluice gate was installed in 2012 as part of the levee construction project. The structure, riser stem, and actuator are in good condition. It is exercised annually and is in good working condition.

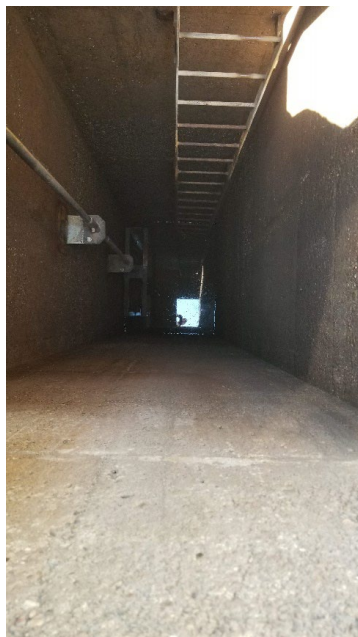
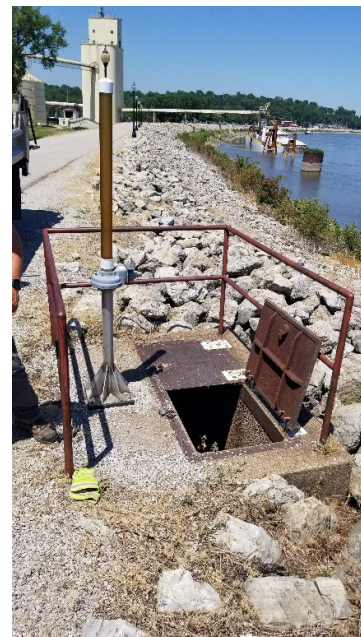
Gatewell 2125 is a gatewell near Musser Park that discharges treated effluent from the Water & Resource Recovery Facility to the Mississippi River. The access hatch and the handrail show mild to moderate corrosion. The gate is approximately 10-15 years old and is typically in the closed position. It is exercised annually and is in good working condition.

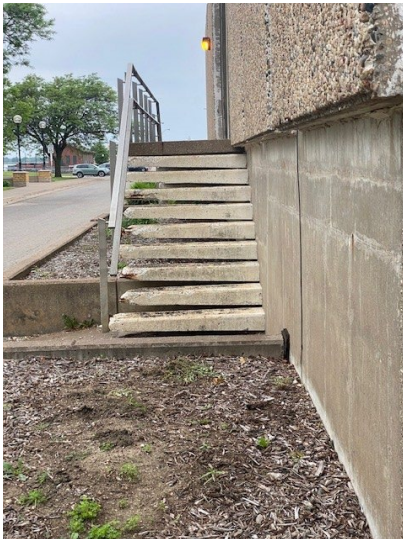
**Figure 3-2: Papoose Exterior Stairs**

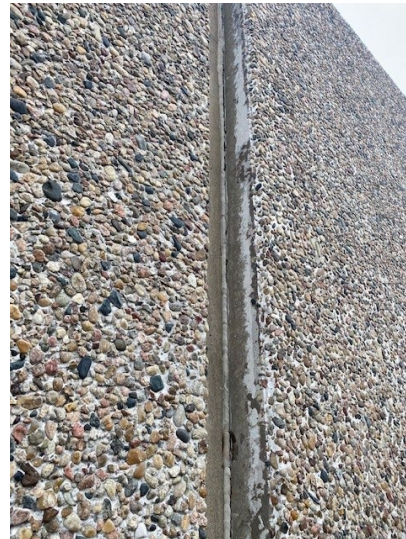
**Figure 3-3: Papoose Exterior Walls**

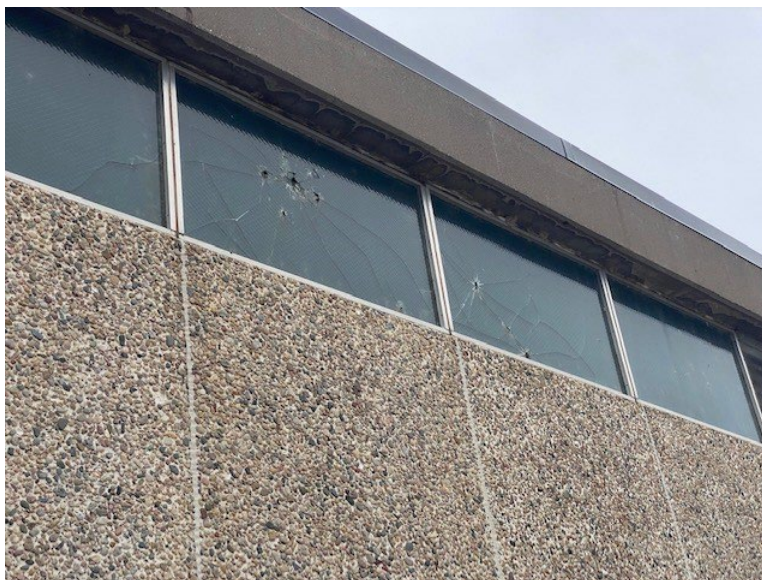
**Figure 3-4: Papoose Windows**

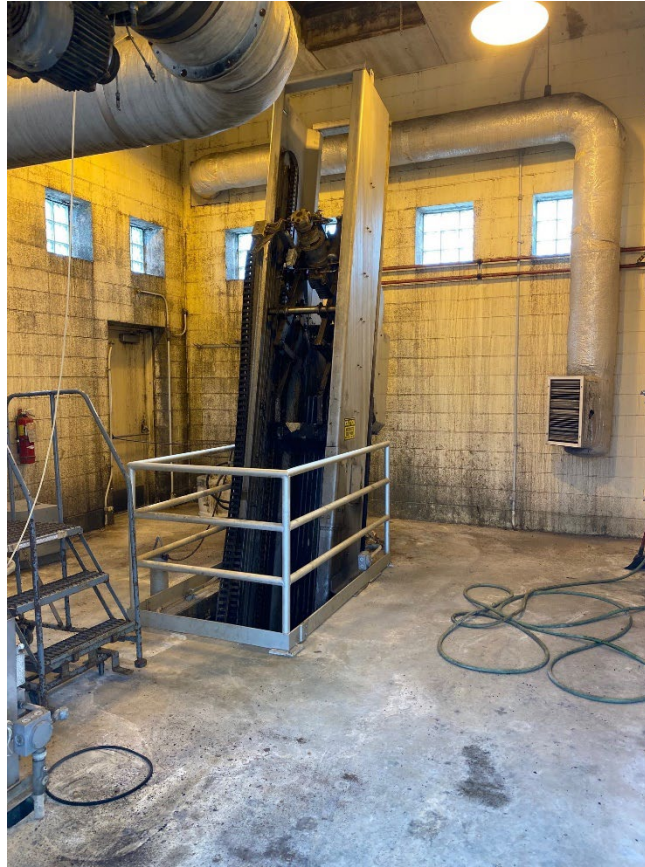
**Figure 3-17: Screening Room at Steward Road Lift Station**

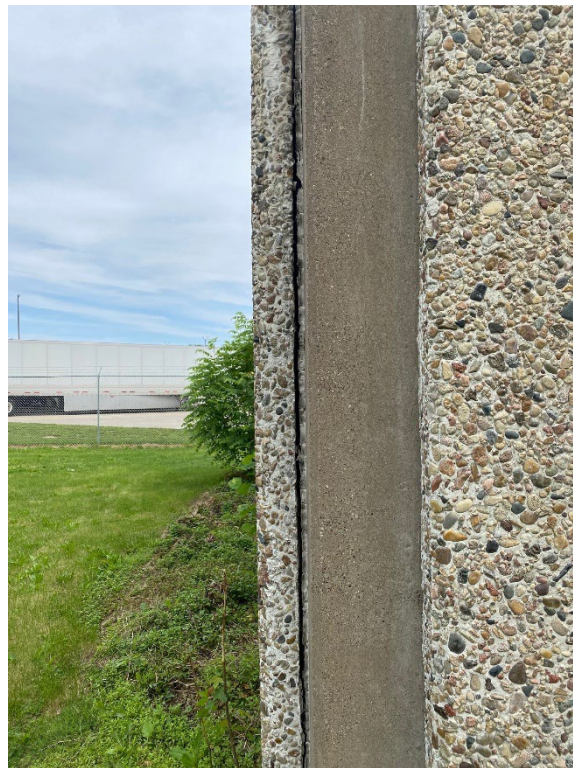
**Figure 3-22: Isett Exterior Wall**

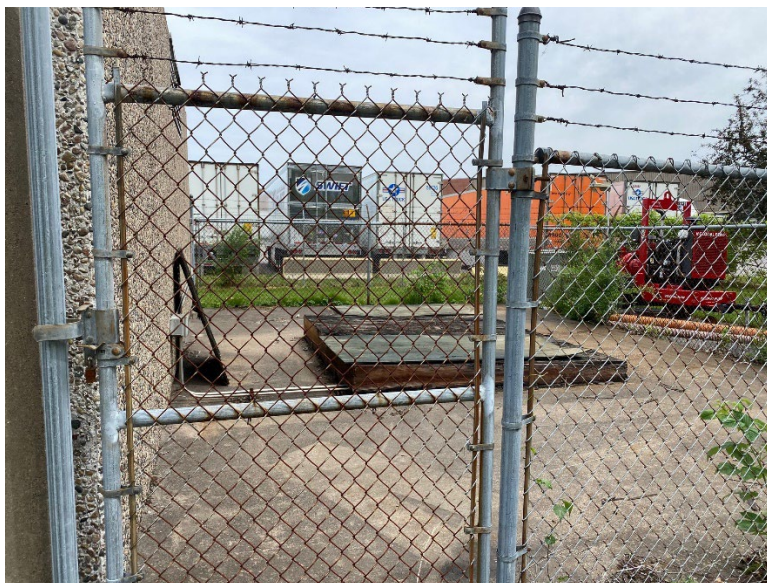
The wet well is covered by a piece of plywood and should be replaced with corrosion resistant cover and hatch.

**Figure 3-23: Isett Wet Well Cover**
