**MUSCATINE CITY COUNCIL  
IN-DEPTH MEETING  
Thursday, April 13, 2023**

Stanley Consultants was selected by a selection committee from three qualified engineering service providers to perform a condition assessment of the Water and Resource Recovery Facility (WRRF), all the City owned lift stations and the gatewells operated along multiple levees in the City. The goal was to establish the general condition of the existing facilities and develop a prioritized capital improvement plan to guide investments in these assets. Each facility was assessed on form, function, redundancy and safety. They were also rated based on consequences of failure. Jay Brady from Stanley Consultants will provide an overview of the Condition Assessment and Capital Improvement Plan Reports including estimated costs associated with the prioritized items and present the working capital improvement plan showing how the City might make investments in these assets over the next 10 years.

**Deliverable:** Capital Improvements Plan  
**Project:** Muscatine WRRF Capital Planning  
**Client:** City of Muscatine  
**Location:** Muscatine, IA

**Deliverable:** Condition Assessment Report  
**Project:** Muscatine WR

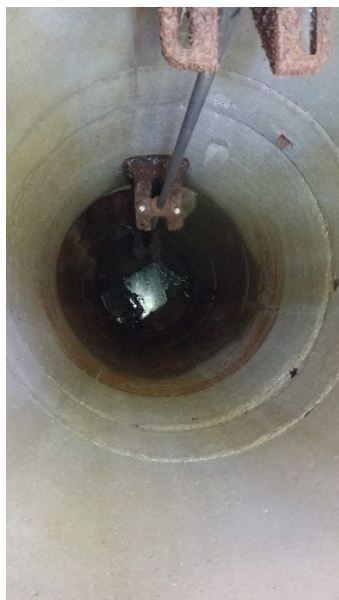
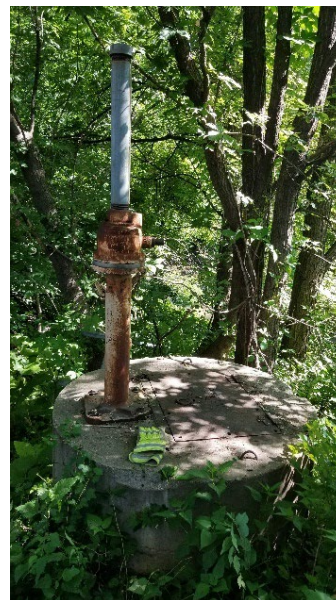
Figure 2-1: GW5073 Interior

GW5073 is a sanitary gatewell. The gate is in the open position but inoperable. The actuator shows significant corrosion. It is located on the east side of the Kraft-Heinz Production Facility, facing Mad Creek. The sewer line crosses Mad Creek and the gate would close if there was a break in the sanitary line causing wastewater flows to enter into the creek. Age of gate is unknown. Its downstream and upstream pipe was installed in 1954. The gate was originally built by the U.S. Army Corps of Engineers (USACE). Our understanding is that there is no Federal government jurisdictional levee at this location. The gate may therefore no longer be required by the Federal government. The USACE should be contacted to confirm whether the gate is required by Federal government. If the gate is required to be operable then the gate should be replaced. Notwithstanding any Federal government requirement, the City may want to consider repairing the gate as a emergency shutoff in the event a sewer break in Mad Creek occurred.

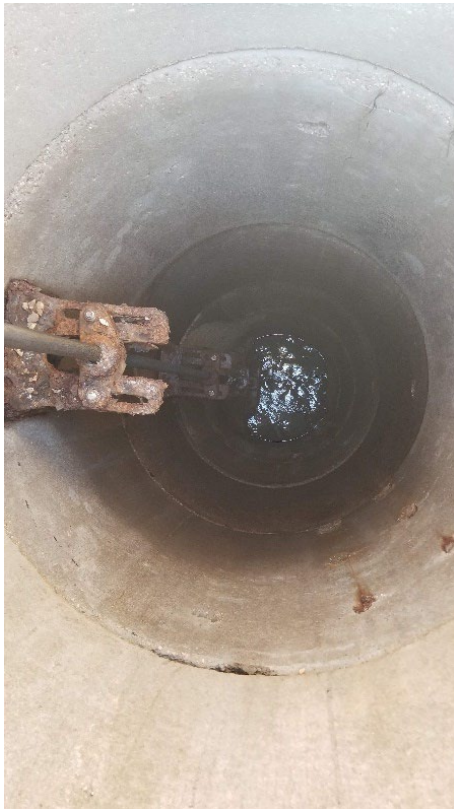
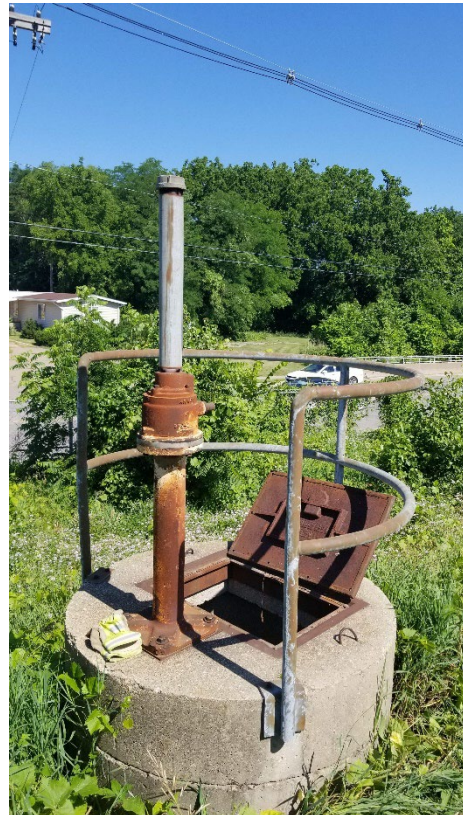
**Figure 2-5: GW 6285 Interior**

GW6285 is a sanitary gatewell, located on the north side of the Kraft-Heinz Production Facility, facing Isett Avenue. The riser stem, actuator, and access hatch show mild to moderate corrosion, but the gate is operable and normally in the open position. The age of gate is unknown. The pipe upstream and downstream was installed in 1967 and 1980. The gate is in adequate condition and is exercised annually.

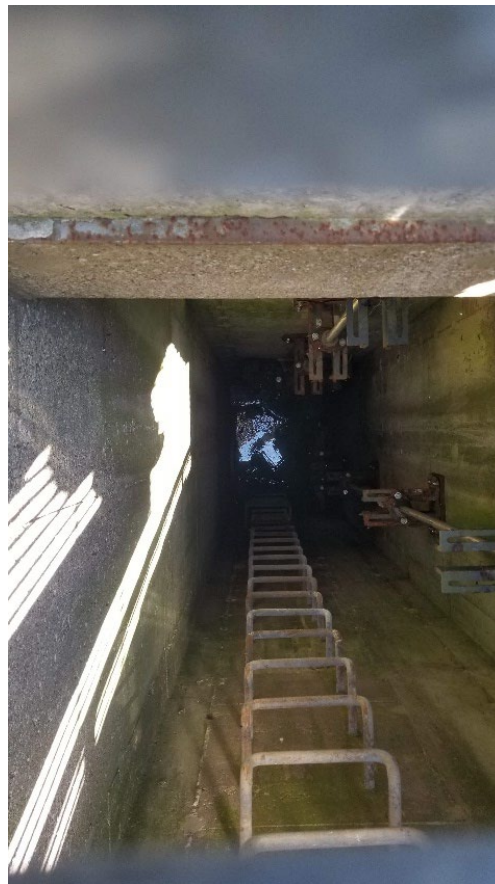
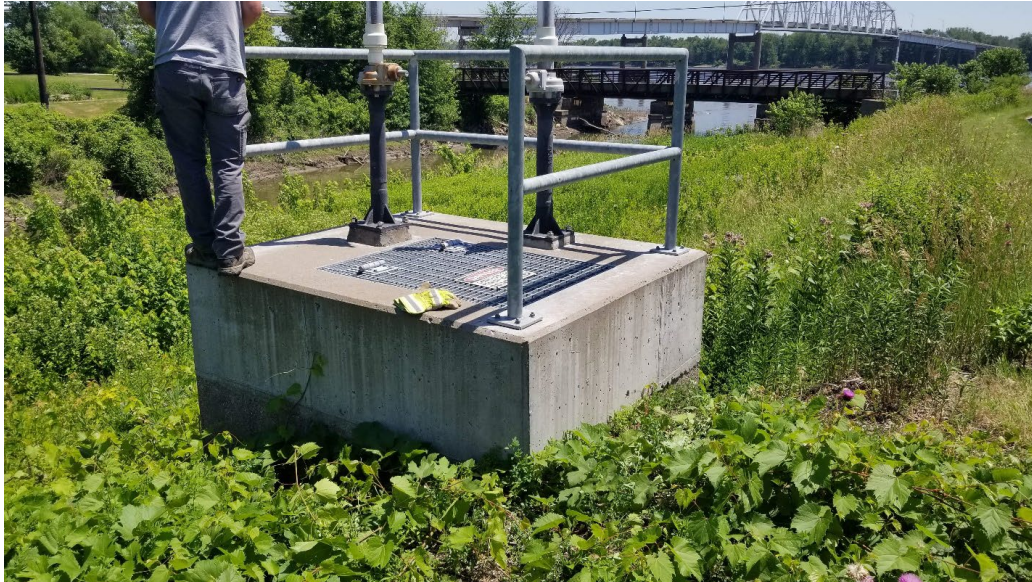
**Figure 2-15: Gatewell 3876 Interior**

GW3876 is a sanitary gatewell located behind the HNI Manufacturing Facility, south of E. 2<sup>nd</sup> St, along Mad Creek. Two new sluice gates were installed in 2011 as part of the levee construction project. One gate diverts flow to the creek and the other date diverts flow to Mad Creek Lift Station. The gates are operable and in good condition.

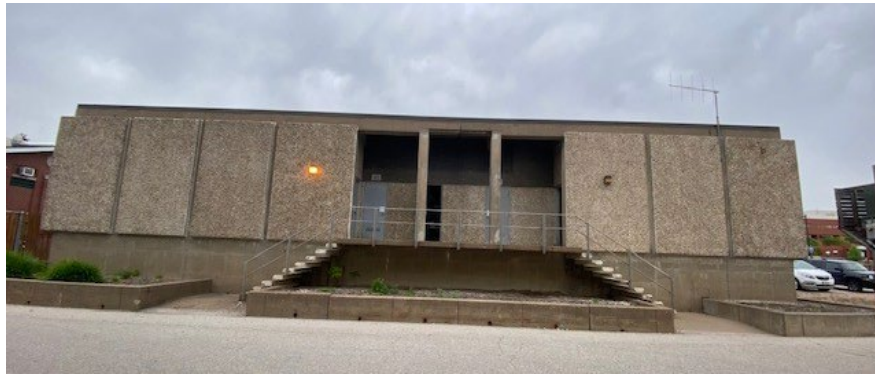
**Figure 3-1: Exterior of Papoose Creek Lift Station**

The basement houses three vertical-shafted pumps with four automated control valves (ACVs) in the dry well and a mechanical bar screen in the wet well. The main floor consists of the electrical control room, the bar screen and compactor room, a janitorial room, a restroom, and the wet wells that separate Papoose Creek from the sanitary sewer collection system.

The pumps, one 75 horsepower (hp) 2,800 gallon per minute (gpm) pump and two 250 hp, 8,600 gpm pumps, are original to the lift station but have been overhauled in the past. The pumps were originally sized to handle combined sewer flows from Papoose Creek. The combined sewer has been partially separated into separate sanitary and storm sewers with complete separation anticipated by 2029. A change in operation has resulted in the lift station only receiving flow from Papoose Creek to relieve pressure within the storm sewer if water levels in the creek are high and when storm flows cannot gravity flow to the Mississippi River. All three pumps are oversized for normal flow, but the higher pumping capacity is needed for flood and storm flows. The 8,600 gpm pumps (PMP500102 and PMP500103) are used infrequently.

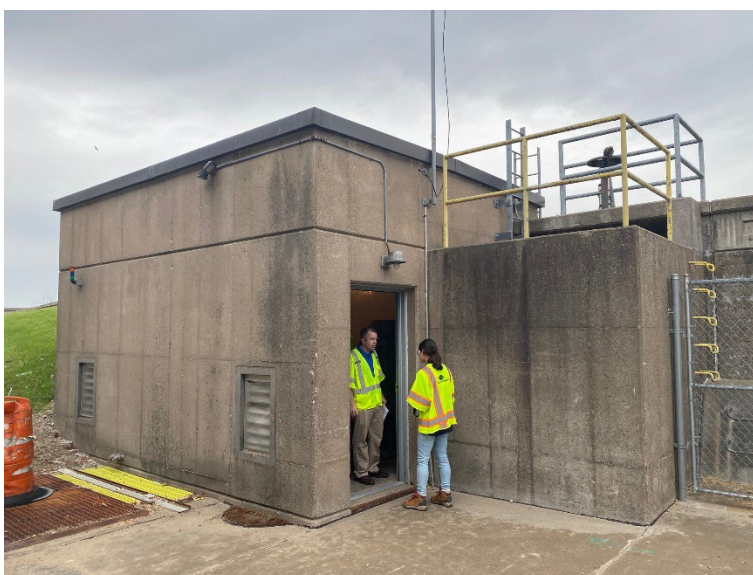
**Figure 3-5: Exterior of Stormwater Lift Station**

The building was constructed in 1957 by the USACE to pump storm water from Mad Creek over the levee to the Mississippi River when river levels are high. The City has maintained the lift station since it has been built. It consists of a concrete building that serves as the electrical/control room with a concrete wet well underneath, and a flat roof. The lift station houses two 16,000 gpm propeller pumps that are original to the building. The building is in good condition and there are no known structural issues.

The two 100 hp, 16,000 gpm propeller pumps were installed in 1957 and are in good condition. The pumps are only used during wet weather conditions when river levels are high. The pumps are exercised routinely,

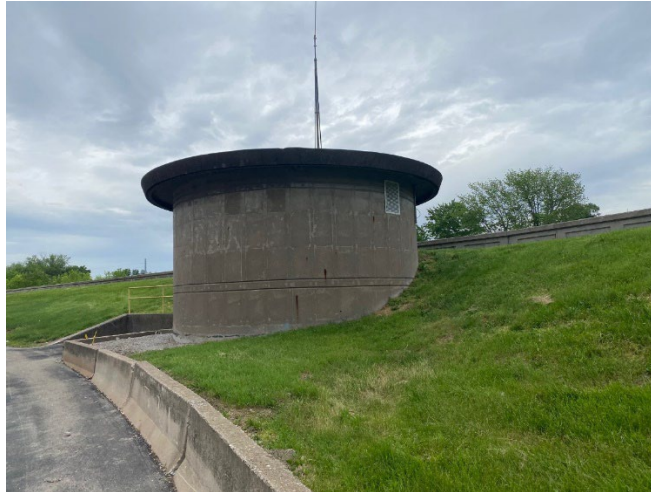
**Figure 3-6: Exterior of Mad Creek Lift Station**

Mad Creek Lift Station was constructed in 1948 to mitigate combined sewage and stormwater flowing to Mad Creek. The lift station is a circular concrete structure with a flat roof. The main floor houses four pump motors and controls. The four extended shaft pumps sit underneath the control room in the dry well.

Pumps 1, 2, and 3 are 1,000 gpm capacity and pump 4 is 5,000 gpm capacity. Pumps 1-3 were replaced in 2000. Slight corrosion can be seen on the pumps and piping; however, pumps are in good condition. Bearings and seals have either been replaced or are scheduled to be replaced on each pump. Pump 4 is original to the station except for the rotating assembly. Staff have no issues with pump capacity and operation. Pumps are adequate capacity and an increase in flow to Mad Creek Lift Station is not anticipated.

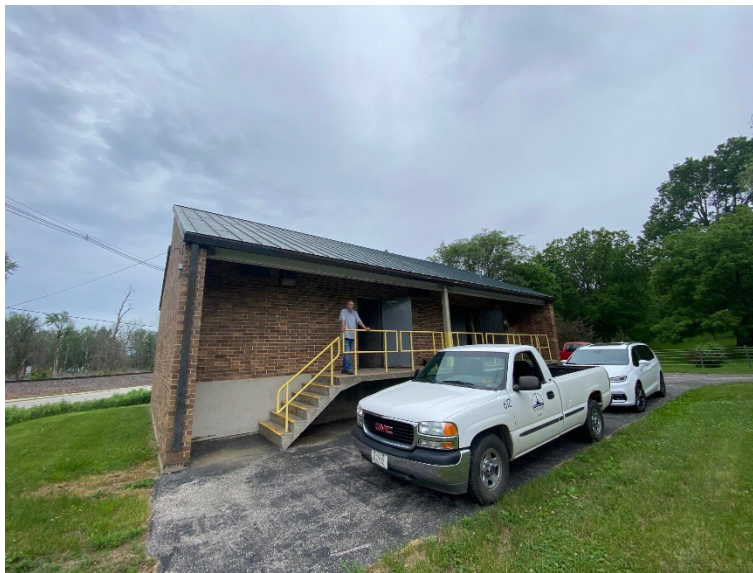
**Figure 3-7: Exterior of Canon Lift Station**

Canon Lift Station was constructed in 1974 to serve the sanitary sewer in the general area. The building is a single-story concrete and brick structure with a sloped roof. The basement houses two 1,500 gpm vertical-shafted pumps in the dry well and a mechanical bar screen in the wet well. The main floor consists of the electrical control room, the bar screen room, and the generator room.

One of the 1,500 gpm shafted pumps (PMP520102) was replaced in 2019. The drive shaft is scheduled for replacement later this year. Pump #1 (PMP520101) is original to the building and requires significant routine maintenance; however, it is scheduled to be replaced later this year. The bar screen is original to the building but is in good condition and requires minimal maintenance. Both pumps are adequate capacity and an increase in flow to Canon Lift Station is not anticipated. Minor corrosion can be observed on equipment.

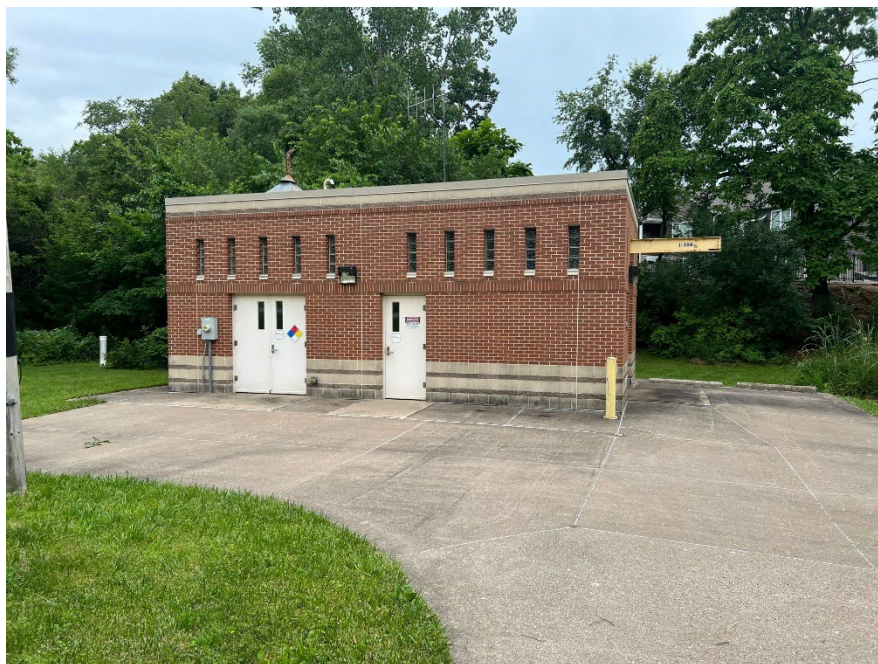
**Figure 3-8: Exterior of Tipton Lift Station**

Tipton Lift Station was completed in 2003 to serve sanitary sewers in the general area. It is a one-story concrete and brick building with a flat roof. It contains a diesel generator room and a control room that sits above the wet well and the four submersible pumps.

Pumps 2 and 3 are 56 gpm capacity and pumps 1 and 4 are 404 gpm capacity. Pumps 2 and 3 do not operate and need to be replaced. Pumps 1 and 4 are used regularly since the two low flow pumps are not operable. These pumps are oversized and inefficient for this application. Pumps are adequate capacity if all four are operable.

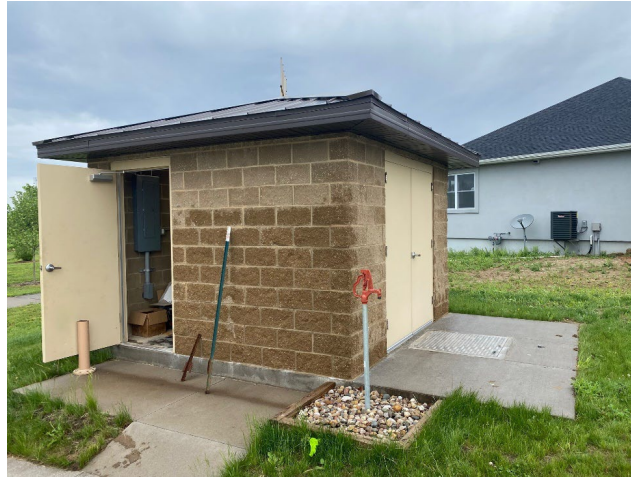
**Figure 3-9: Exterior of Arbor Commons Lift Station**

Arbor Commons Lift Station was completed in 2020 to serve sanitary sewers in the general area. It is a one-story concrete and CMU building with a sloped metal roof. Control panels and two suction lift pumps are housed inside the building. A natural gas generator sits outside behind the lift station.

The station was built for a new housing development and contains two 100 gpm suction lift pumps with self-priming belts. Only a few houses have been development at this point, so flow is minimal. The pumps run under high net pressure suction head and on occasion get air locked. Both pumps are adequate capacity for when subdivision is fully developed. Bearing and seals may need replacement more frequently until flows increase.

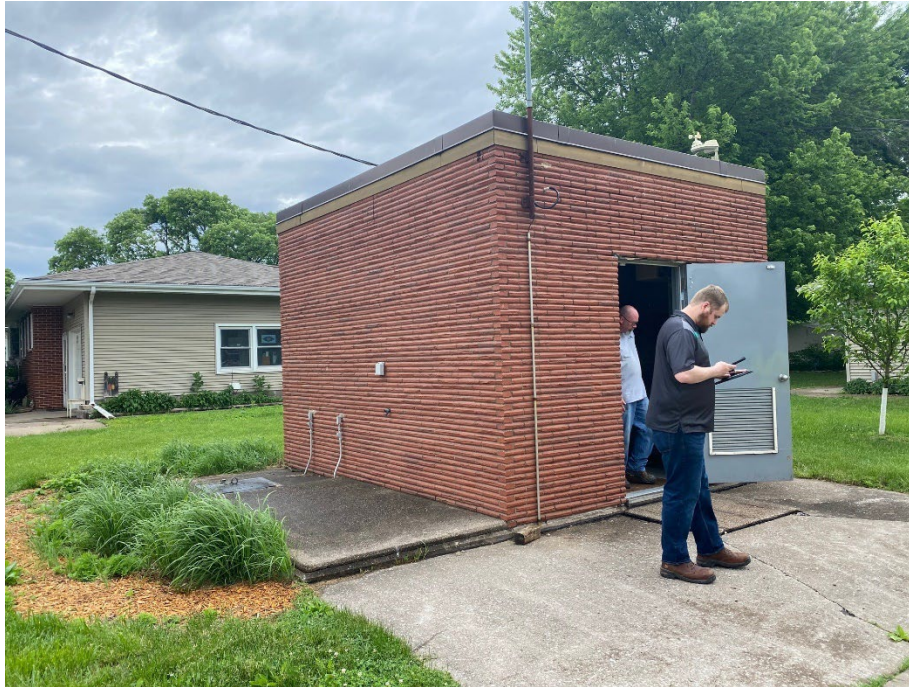
**Figure 3-10: Exterior of Houser Lift Station**

Houser Lift Station was completed in 1968 to serve sanitary sewers in the general area. It is a one-story concrete and brick building with a flat roof. The station is a wet well/dry well arrangement with the control room and pump motors located above the dry well. The extended shaft pumps are located in the dry well.

The two 300 gpm pumps are original to the lift station. The pumps are higher maintenance since the seals need to be repacked and pumps rebuilt every couple of years. The pump shafts do not have cages which poses a safety hazard. Both pumps are adequate capacity for normal conditions and an increase in flow to Houser Lift Station is not anticipated. The lift station receives high wet weather flows that lead to sewer surcharging and periodic basement backups. It is not known whether the pumps are too small for the peak wet weather flows or if the sewers cannot adequately convey the flow to the lift station to avoid surcharging. If pumps are replaced, sizing should be evaluated.

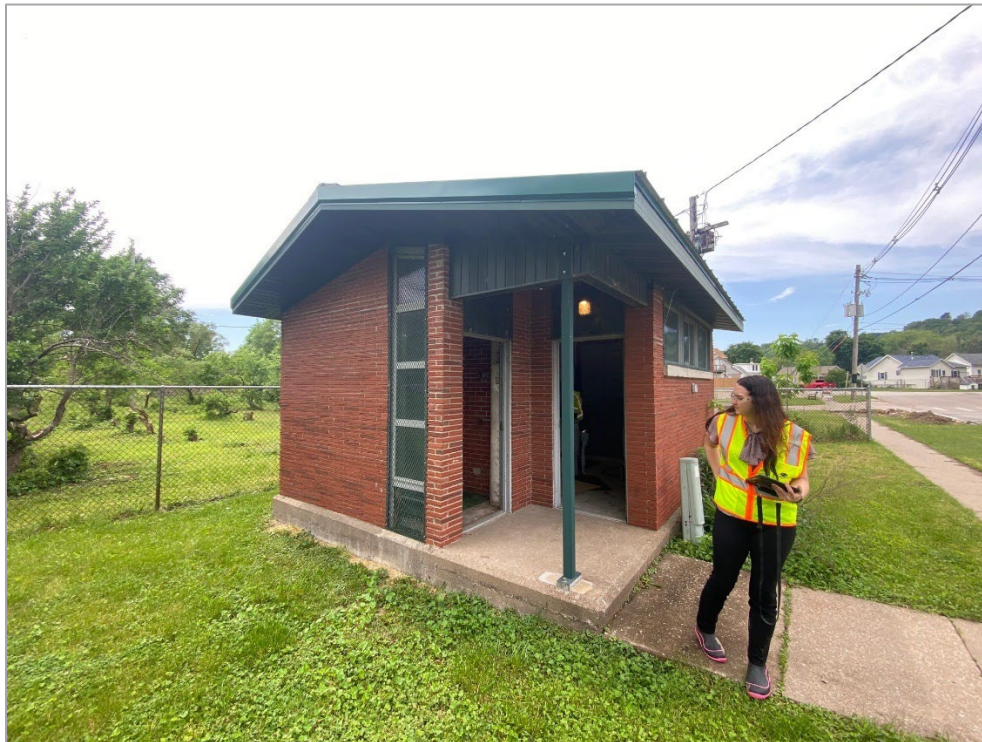
**Figure 3-11: Exterior of Bond Lift Station**

Bond Lift Station was completed in 1957 to serve sanitary sewers in the general area. It is a one-story concrete and brick building with a sloped metal roof. Roof was replaced in 2012. The station is a wet well/dry well arrangement with the control room and pump motors located above the dry well. The extended shaft pumps are in the dry well.

The three 1,020 gpm pumps and associated valves were replaced in 2009. The drive shafts have not been replaced. Pumps have been low maintenance and there are no operational concerns. The City is building a splash pad nearby so the lift station will see an increase in flow. Pump 1 has a natural gas-powered engine in case of emergency. The City plans to replace Pump 1 with a larger size pump to accommodate seasonal higher flows.

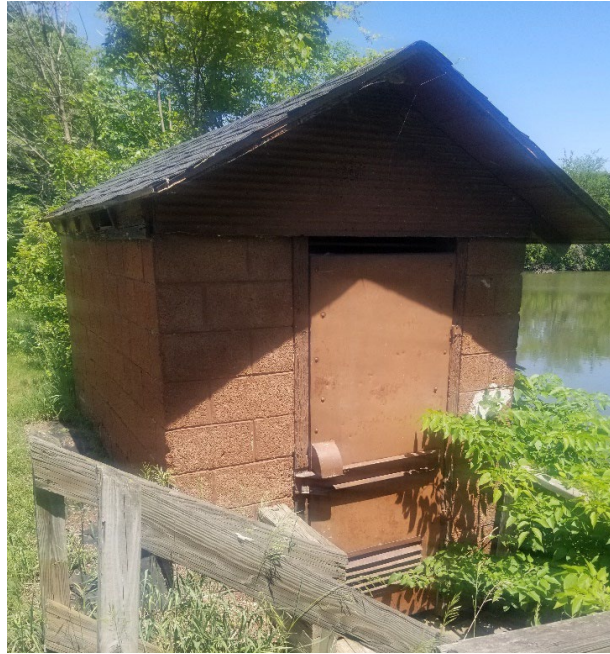
**Figure 3-12: Exterior of Slough Lift Station**

The Slough Lift Station was constructed prior to 1965 to manage the water elevation in the slough. It is a single-story concrete and CMU block building with a shingled roof. The structure houses two vertical turbine pumps and pump controls.

Pump capacity is 6,000 gpm and both pumps are original to the lift station. The pumps operate a few times per year when the slough is high. The station is not on SCADA, so City staff turn the pumps on by hand. The City does not have any operational or maintenance issues with the pumps. Pump capacity is adequate.

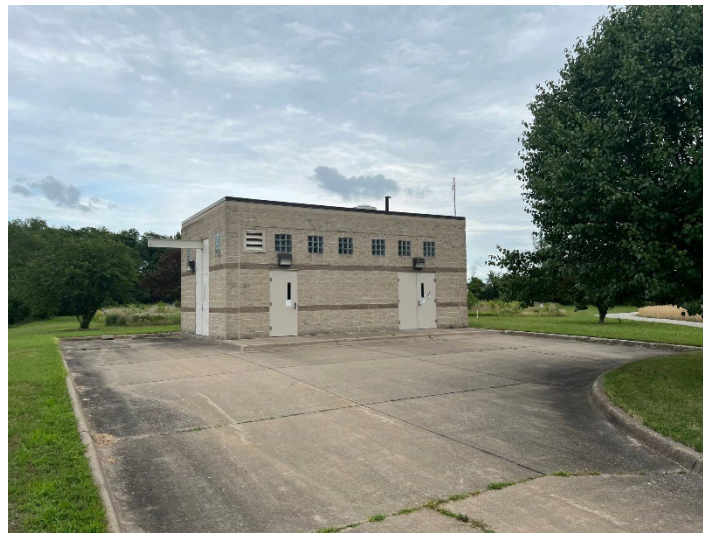
**Figure 3-13: Exterior of Sampson Lift Station**

Sampson Lift Station was completed in 1999 to serve sanitary sewers in the general area. It is a one-story concrete and CMU block building with a flat roof. It contains a diesel generator room and a control room that sits above the wet well and two submersible pumps.

Both pumps have a capacity of 980 gpm and are original to the lift station. City staff have no operational or maintenance concerns with the pumps. Pump capacity is adequate.

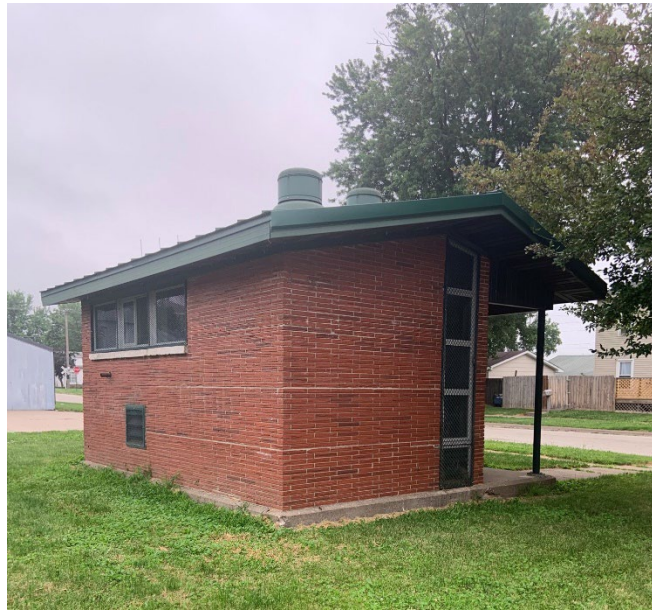
**Figure 3-14: Exterior of Schley Lift Station**

Schley Lift Station was constructed in 1957 to serve sanitary sewers in the general area. It is a one-story concrete and brick building with a sloped metal roof. Roof was replaced in 2012. The station is a wet well/dry well arrangement with the control room and pump motors located above the dry well. Three extended shaft pumps are in the dry well. One of the pumps has a natural gas powered motor in case of emergency. Wet well can also overflow to Miles Lift Station in case of pump failure.

Each pump has a capacity of 1,020 gpm. Pumps 1 and 2 have new drive shafts and have been rebuilt in 2019. Pump 3 shows signs of leaking around the packing gland and the pump casing appears corroded. The pump is original to the lift station.

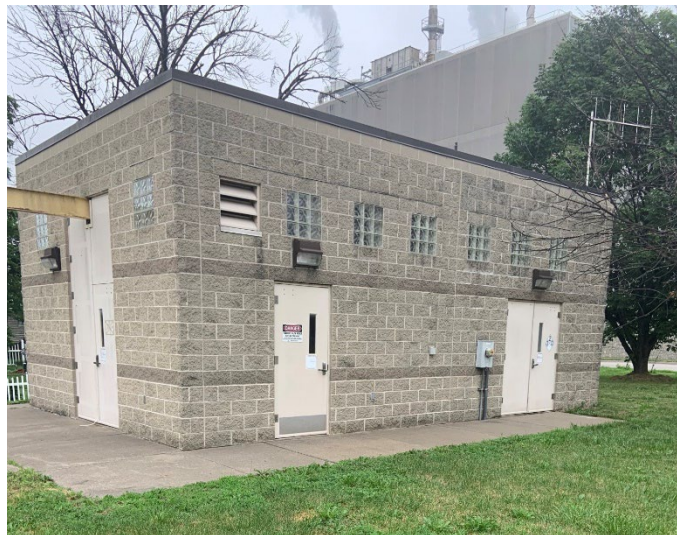
**Figure 3-15: Exterior of Miles Lift Station**

Miles Lift Station was completed in 2000 to serve sanitary sewers in the general area including domestic flow from GPC. The structure is a one-story concrete and CMU block building with a flat roof. It contains a diesel generator room and a control room that sits above the wet well and two submersible pumps. GPC waste is tested regularly using an automated sampler located in control room.

Both pumps have a capacity of 350 gpm and are original to the lift station. City staff have no operational or maintenance concerns with the pumps. Pump capacity is adequate.

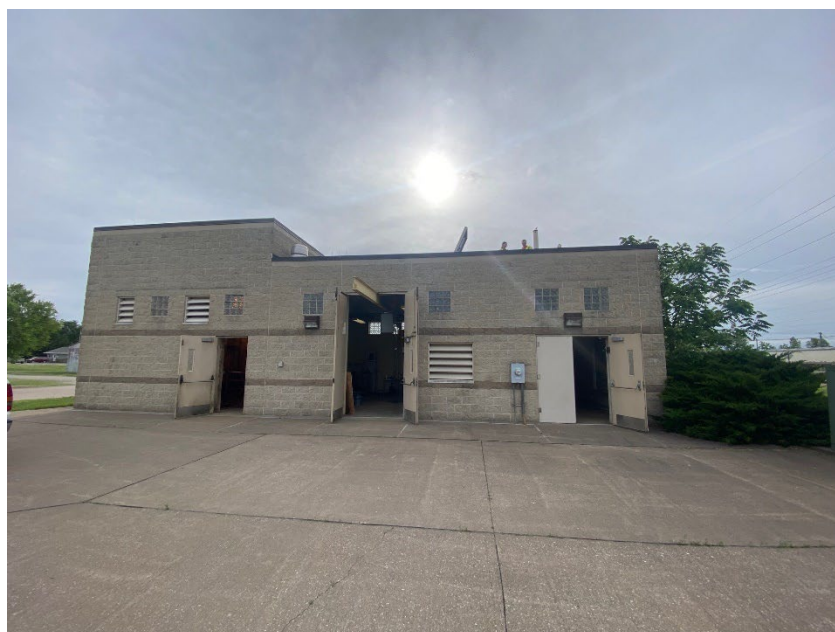
**Figure 3-16: Exterior of Stewart Road Lift Station**

Stewart Road Lift Station was completed in 2000 to serve sanitary sewers in the general area. It is a one-story concrete and CMU block building with a flat roof. Windows are glass block. Structure contains a diesel generator room, a motor control room, and a screening room. The basement houses two vertical-shafted pumps in the dry well and a mechanical bar screen in the wet well.

Each pump has a capacity of 1,680 gpm. Both pumps were rebuilt in 2019. The drive shaft for pump 2 was replaced in 2019. Pumps show signs of leaking around the packing gland and the pump casing appears corroded. The drive shafts are missing cages.

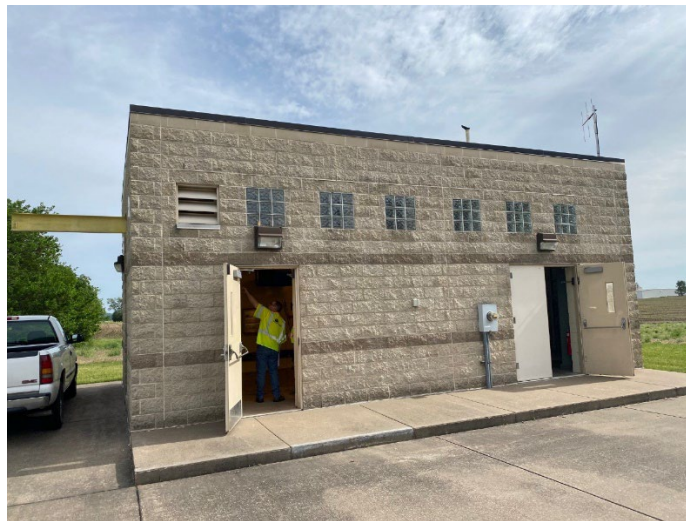
**Figure 3-18: Exterior of 57th Street Lift Station**

57th Street Lift Station was completed in 2002 to serve sanitary sewers in the general area. It is a one-story concrete and CMU block building with a flat roof. It contains a diesel generator and two submersible pumps.

The two 480 gpm submersible pumps were installed in 2002 and are in good condition. Staff have no issues with pump capacity and operation. Both pumps are adequate capacity and an increase in flow to 57<sup>th</sup> Street Lift Station is not anticipated.

The structure appears in good condition, and there are no reported issues with the roof or building by City staff.

- » Add makeup air unit for wet well containing screen.
- » Replace the unit heaters in the facility.
- » Replace the backflow preventer.

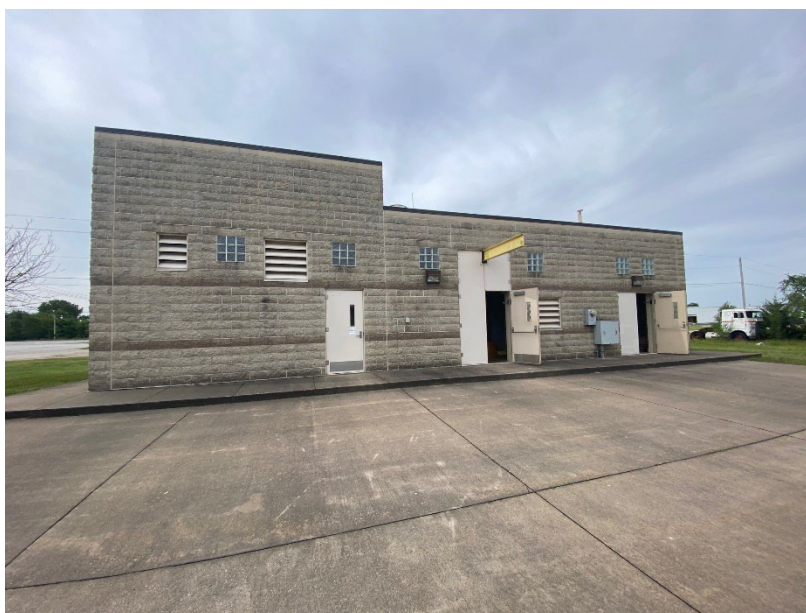
**Figure 3-19: Exterior of Progress Park Lift Station**

Progress Park Lift Station was completed in 2002 to serve sanitary sewers in the general area. It is a one-story concrete and CMU block building with a flat roof. Windows are glass block. Structure contains a diesel generator room, a motor control room, and a screening room. The basement houses two vertical-shafted pumps in the dry well and a mechanical bar screen in the wet well.

Each pump has a capacity of 2,510 gpm. Pump 1 and drive shaft were rebuilt in 2019. Pump 2 has a bad seal and casing shows corrosion. The City plans to rebuild pump 2 in the near future. Pumps capacities are adequate at this time.

The mechanical bar screen is original to the lift station and appears in good condition. City staff have no maintenance or operation concerns.

One of the access door handles is broken and a rope is tied from the door handle to the bar screen railing to keep the door shut.

Control Room: the wet well area and screen room HVAC system consists of a makeup air unit, an exhaust fan, and unit heater. The makeup air unit and exhaust fan are non-operational. The backflow preventer showed signs of corrosion. All units are original to the building and are past service life. The unit heater appeared to be operational but is also past service life.

- » Replace or rebuild pump 2 using mechanical seals rather than packing to reduce maintenance costs.
- » Add cage around pump 1 drive shaft for safety.
- » Replace Exhaust fans serving the wet well, screen room, and dry well areas to maintain a safe environment for City staff.
- » Replace the makeup air units serving the wet well, screen room, and dry well to maintain a safe environment for City staff.
- » Replace the exhaust fans serving the generator room and control room to maintain space temperatures suitable for equipment operation.
- » Replace unit heaters to maintain freeze protection of the facility.

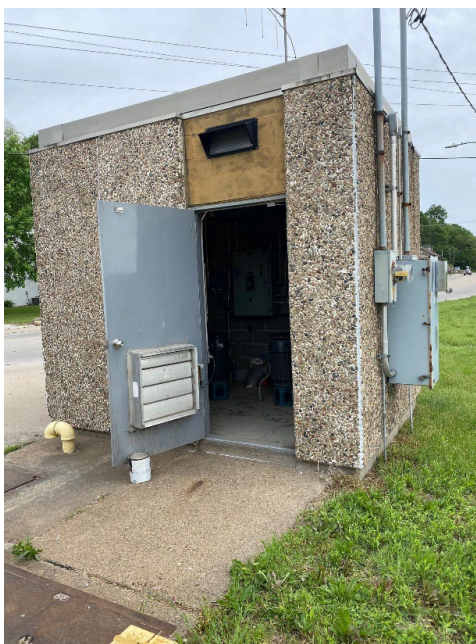
**Figure 3-20: Exterior of Hershey Lift Station**

Hershey Lift Station was completed in 1964 to serve sanitary sewers in the general area. It is a one-story precast concrete panel building with a flat roof. The station is a wet well/dry well arrangement with the control room and pump motors located above the dry well. Two extended shaft pumps are in the dry well.

Each pump has a capacity of 310 gpm. The original pumps had been replaced with the current installed pumps. The pumps have been rebuilt in the last few years. The City has no maintenance or operation concerns. Pumps capacities are adequate.

Dry Well: the dry well exhaust fan is located above in the control room, with ductwork extending to the floor of the dry well. The fan was operation at the time of assessment. Fan should be replaced due to both age and safety concerns.

Power is supplied by two different utility sources through an automatic transfer switch. The two 15 HP motors have wall mounted across the line starters and are powered from a 480V panelboard. Electrical equipment is original to the building and was installed in 1968. The electrical equipment is beyond its service life and should be replaced.

- » Replace fixed ladder if current ladder does not meet OSHA standards.
- » Replace exhaust fans to maintain a safe environment for City staff.
- » Replace the unit heater to maintain freeze protection of facility.
- » Pump motors are currently operable and are not considered critical items, but due to age, efficiency, and availability of replacement parts, these assets should be replaced in the near future. A City implemented motor replacement program is recommended to make sure all motors are replaced in a timely manner before a failure occurs.

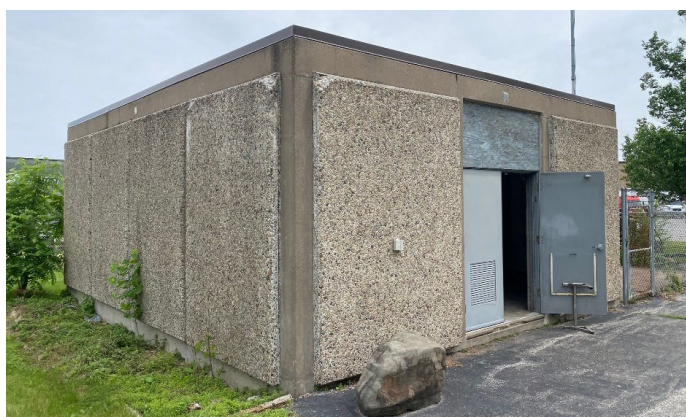
**Figure 3-21: Exterior of Isett Lift Station**

Isett Lift Station was completed in 1967 to serve sanitary sewers in the general area but predominately the Kraft Heinz plant. It is a single-story facility that consists of a poured foundation/basement, a concrete building frame with a precast concrete panel exterior, and flat roof. The basement houses three vertical-shafted pumps. The main floor consists of the electrical control room and pump motors. Wet well can overflow to Mad Creek Lift Station if levels get too high. The Heinz plant accidentally filled the bypass line with concrete and are working to replace the bypass line.

Pumps 1 and 2 have a capacity of 3,900 gpm. Pump 3 has a capacity of 6,400 gpm. Pump 1 was replaced in 2003 and then rebuilt in 2021. The suction line has a hole and causes excessive leaking. The area is difficult to access and fix. Pump 2 and the drive shaft were replaced in 2013. Pump 3 is original to the lift station and is inoperable. The discharge valve is broken and there is no platform to access the drive shaft so pump cannot be replaced. Pump 1 and 2 alternate operation and will operate together under high flow conditions. If pump 1 and 2 cannot keep up with flows the lift station currently does not have a bypass line or a redundant/high flow pump. All pumps and piping appear corroded.

The wet well is covered by a piece of plywood and should be replaced with corrosion resistant cover and hatch.

**Control Room:** the control room HVAC consists of electric unit heaters for heating and exhaust fans for ventilation cooling. The exhaust fans are functional, but one fan requires the motor bearings to be replaced, and both units are past service life. Door louvers provide makeup air, but these were closed during the assessment. Two unit heaters were installed new last year after an old unit caused an arc flash fire. A third unit heater is yet to be installed. Thermostats were not secured to the wall yet either.

**Dry Well:** the dry well exhaust fan is located above in the control room, with ductwork extending to the floor of the dry well. The fan, which is original to the building, only operates when staff is present. The ductwork in the dry well showed minor signs of deterioration and corrosion. Operators noted the floor drains are plugged at the bottom of the dry well, and standing water was noted. Operators also noted short service life of the floor drains, which have been replaced two to three times already due to corrosion.

Power is supplied by a single utility source and feeds a motor control center that feeds a 125 HP motor and soft starter, a 150 HP motor and soft starter, and a 200 HP motor and across the line starter. The motor control center recently had a critical failure and has since been replaced in 2021. The rest of the electrical equipment is original to the building and was installed in 1967 and is beyond its serviceable life.

- » Replace all three pumps with dry pit submersible pumps since staff cannot access the drive shafts safely or continue to use shafted pumps but install platforms in the dry well for shaft and valve access.
- » Building Updates: Replace wet well cover. Seal air gaps and reinforce walls.
- » Replace the dry well and control room exhaust fans to provide a safe environment for City staff.
- » Install an emergency generator to ensure the lift station will maintain operation if a power failure occurs.
- » Clear the drain lines in the dry well and replace the floor drains with more corrosion resistant type products.

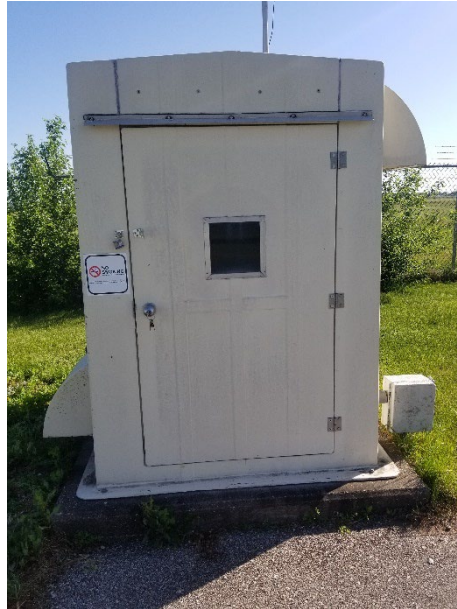
**Figure 3-24: Exterior of Airport Lift Station**

Airport Lift Station was constructed in 2002 to serve sanitary sewers in the general area. It is duplex submersible lift station with a concrete and fiberglass structure that houses the controls.

Both pumps have a capacity of 100 gpm and are original to the station. Pump 2 had the moisture sensors replaced four years ago. No other major maintenance has been required. Pump capacity is adequate and flow to the lift station is projected to remain the same.

The structure appears in good condition, and there are no reported issues with the roof or building by City staff.

No recommendations for repair or replacements are currently necessary.

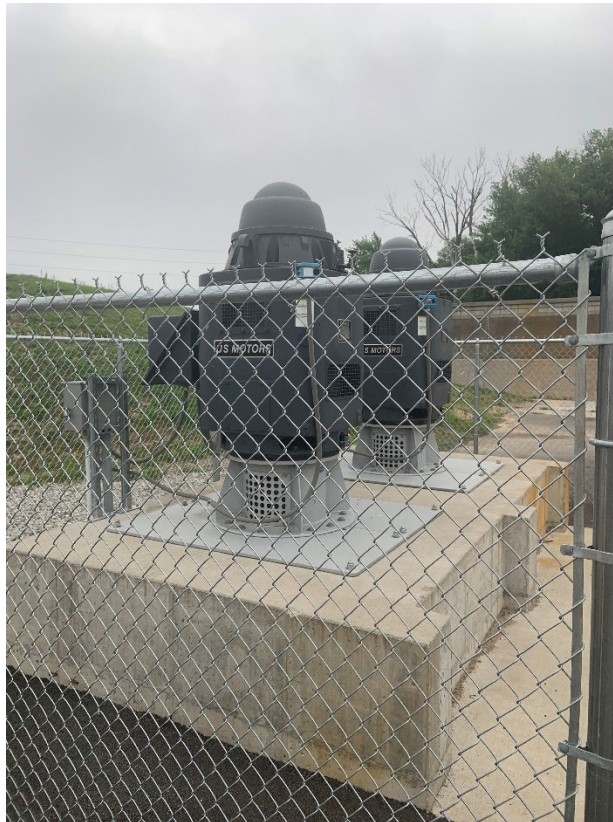
**Figure 3-25: Exterior of HNI Stormwater Lift Station**

HNI Stormwater Lift Station was constructed in 2019 to mitigate stormwater flows into Mad Creek. Lift station pumps flow over levee into Mad Creek when river level is above 10 feet. It is duplex turbine lift station with pump motors and controls mounted outdoors on a concrete pad. The lift station was constructed by HNI with the intent of the City taking over maintenance, but no formal agreement has been signed as of April 2023.

Both pumps have a capacity of 18,000 gpm. The lift station has not experienced much flow since being built, but pumps seem to be adequate size and are in good condition.

The structure appears in good condition, and there are no reported issues by City staff.

No recommendations for repair or replacements are currently necessary.

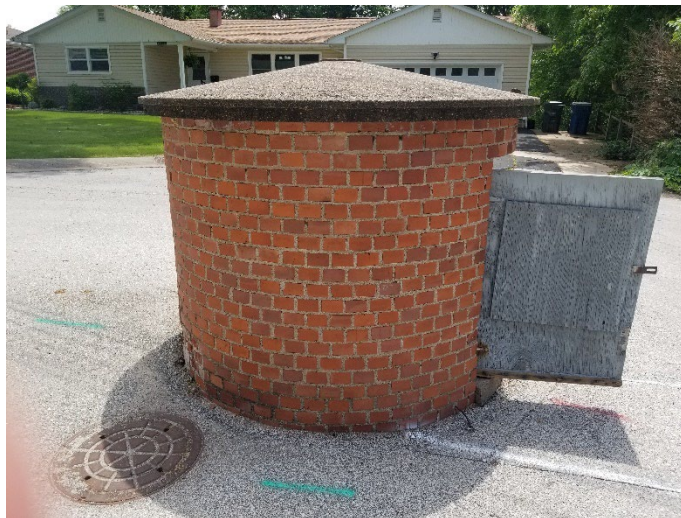
**Figure 3-26: Exterior of Magnolia Lift Station**

Magnolia Lift Station was constructed prior to 1965 to serve sanitary sewers in the general area. It is simplex submersible lift station with a brick riser that houses the controls.

The single pump has a capacity of 100 gpm and is original to the station. There is no redundancy, and the station is not viewable on SCADA. However, pump capacity is adequate and flow to the lift station is projected to remain the same. The city plans to replace lift station with a new duplex system this year. The control panel will be removed from the riser structure and will be mounted aboveground. Subsequent to the finalization of the condition assessment report, the City replaced the simplex system with a duplex system and added a new control panel with alarm near the curb. The City plans to remove the building and pave over surface in the spring of 2023.

The structure appears in adequate condition, and there are no reported issues with the roof or building by City staff.

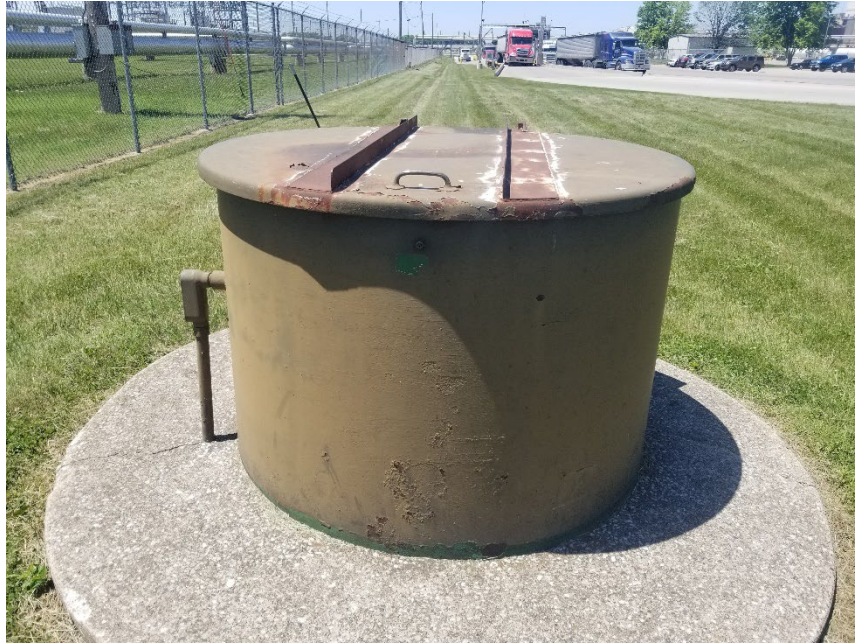
**Figure 3-27: Exterior of Maple Grove Lift Station**

Maple Grove Lift Station was constructed in the 1970s to serve sanitary sewers for a small subdivision. It is an air ejector system with a metal riser that houses the controls.

Both air compressors are original to the station. One air compressor is scheduled to be replaced this year. The station is not viewable on SCADA, and City staff need to visit the site three times per week to manually turn on system to empty wet well. The lift station goes through overloads, and contacts and capacitors need to be replaced every couple of years. The wet well used to be able to bypass to Steward Lift Station but cannot gravity flow through anymore.

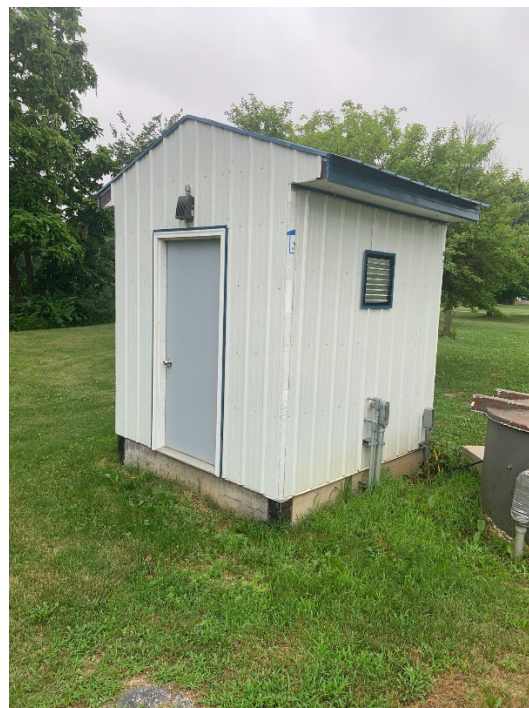
**Figure 3-28: Exterior of Sunset Lift Station**

Sunset Lift Station was constructed in 1981 to serve sanitary sewers in the general area. The system has a wet well/dry well configuration. Prior to two years ago the controls were mounted underground and access to the panel was through a metal riser structure. City staff have now moved the control panel aboveground into a fiberglass shed. Dry well currently has two active pumps with space for a third pump.

The two installed pumps have two-speed motors with a capacity of 200 gpm. Pump 1 is original to the station but has a new rotating assembly. Pump 2 is a dry pit submersible that was installed in 2021. Staff need to use a retrieval system to enter the confined space dry well and only enter twice a year unless unexpected maintenance is required. An increase in flow is expected from Phelps and Lutheran Homes. City staff plan to install a spare dry pit submersible pump on the third volute so the station can accommodate future flows.

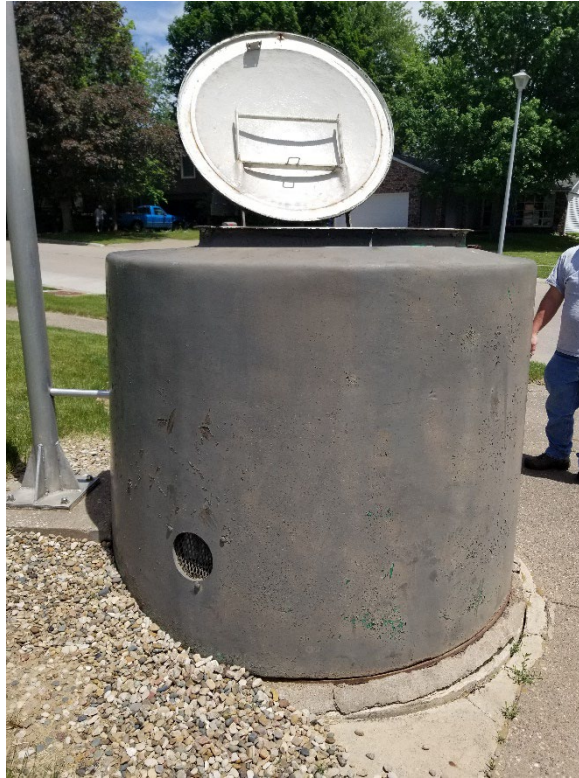
**Figure 3-29: Exterior of Tanglefoot Lift Station**

Tanglefoot Lift Station was completed in 1972 to serve sanitary sewers in the general area. It is a concrete structure with two submersible pumps.

The pumps have a capacity of 200 gpm and are original to the station. Staff have no operation and maintenance concerns with the pumps.
